Seismic Damage Evaluation for Low-Rise RC School Buildings in Taiwan

Yi-Hsuan Tu¹, Pei-Lin Yeh², Tzu-Wei Liu³

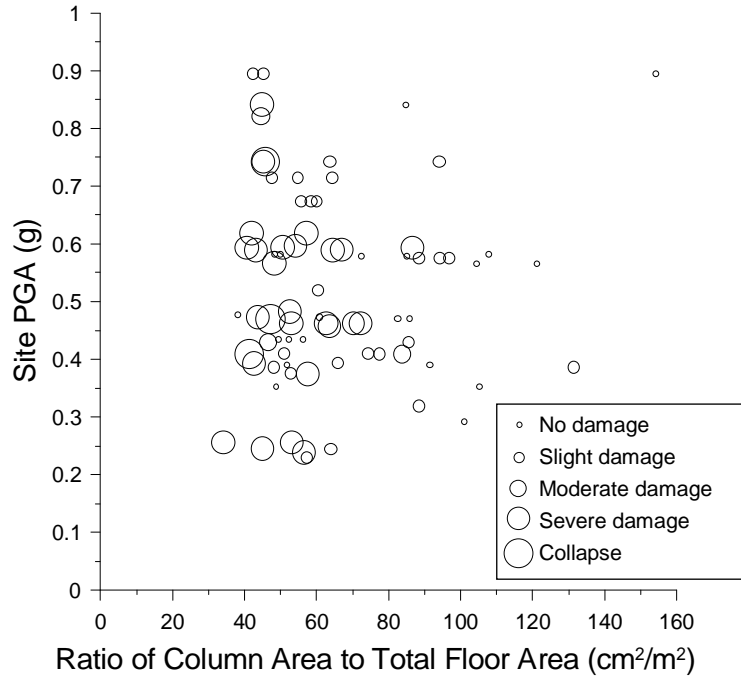
Fig. 2 Relationship between Site PGA, Column Area Ratio, and Damage State

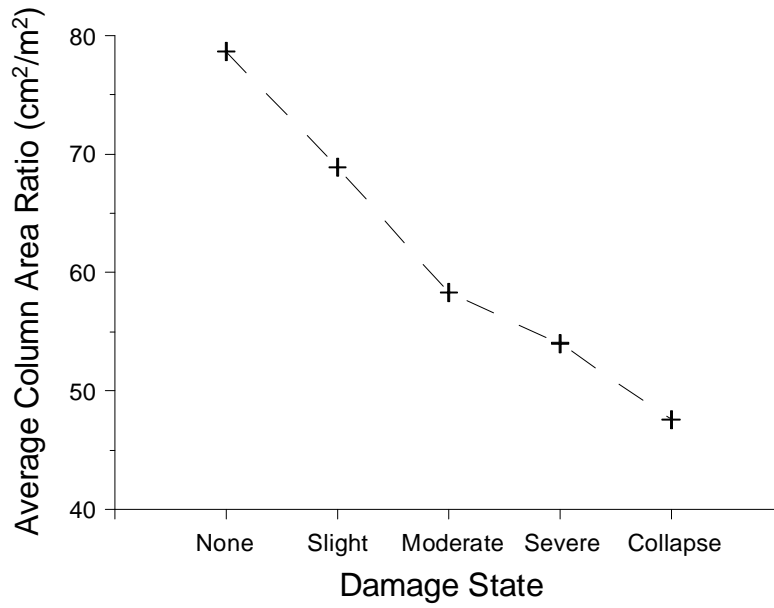
Fig. 3 Relationship between Average Column Area Ratio and Damage State
