Roble Hall at Stanford University: A Case Study in the Evolution of Seismic Rehabilitation Standards

Bret Lizundia¹

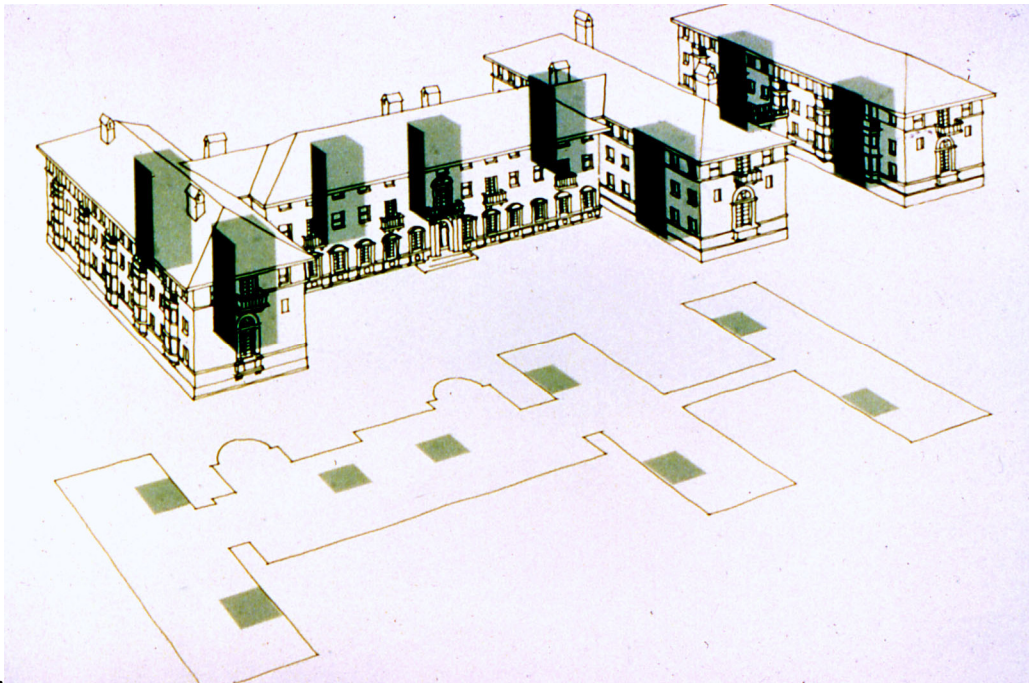
Figure 1. Concrete shear wall tower locations in the 1988 seismic rehabilitation.
