Structural and Environmental Stabilization of a Historic Wood-Framed Museum

Gary R. Searer, Wiss, Janney, Elstner Associates, Inc., gsearer@wje.com
James A. Mahaney, Wiss, Janney, Elstner Associates, Inc., jmahaney@wje.com

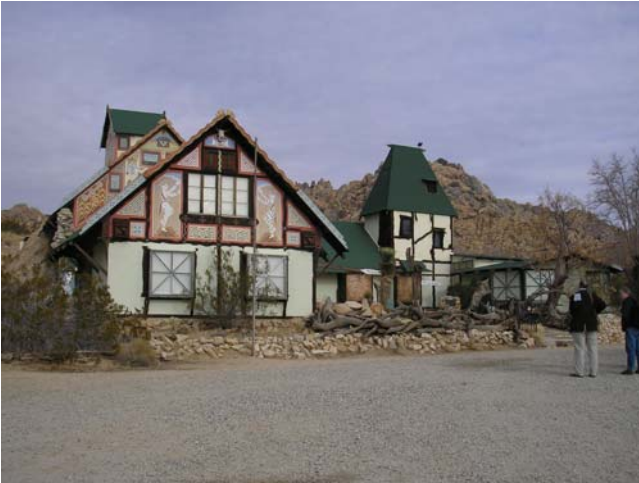
Figure 1: Antelope Valley Indian Museum

The Antelope Valley Indian Museum (Figure 1) is a historic one- and two-story wood-framed structure, built in the late 1920s through the 1930s near Lancaster, California. The museum houses a collection of Native American artifacts and also documents how these artifacts were interpreted by the various owners and curators, including the original owner, Howard Arden Edwards. Given that the collection was inadequately protected from temperature fluctuations, the State of California embarked on a program to insulate the building, heat and cool the museum using geothermal heat sinks, and structurally and seismically rehabilitate the building.

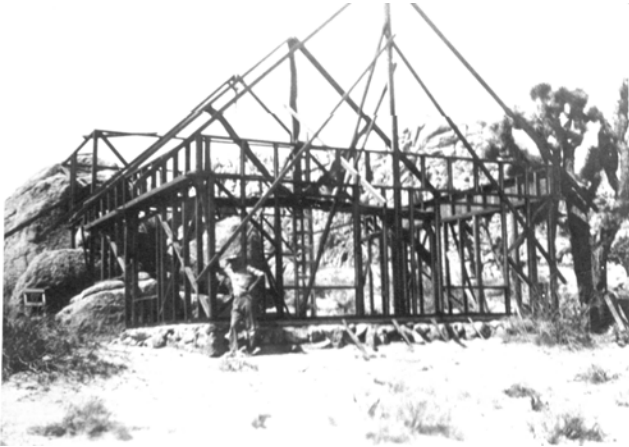
Figure 2: Historic photo of construction of the Antelope Valley Indian Museum

The existing structure was not engineered and was built in several phases with a minimum of structural framing elements, even considering standard construction practices in the 1920s and 1930s (Figure 2). Roof sheathing is composed of 1x boards that span between steeply pitched 2x4 roof rafters at up to 4-feet on center. The roof sheathing and framing are not adequate to support code-level live loads, making re-roofing as well as structural strengthening difficult. The addition of insulation and associated wood framing to the roof of the museum adds a significant amount of weight -- nearly doubling the weight of the structure. The structure resists lateral forces through straight-sheathed roof diaphragms, weak frame action of the roof trusses and exterior walls, and perpendicular walls. The structure is so flexible, it visibly moves during windstorms. As the interior finishes are actually the exposed structural elements, structural strengthening to protect the historic elements of the structure can result in the diminishment or destruction of the very historic elements one is trying to protect -- particularly if the strengthening is not performed judiciously; consequently any structural intervention must be carefully weighed against the potential impacts on the historic fabric and against cost of the work. In this case, nearly every surface is covered with painted murals and artwork, making traditional strengthening and rehabilitation measures (such as adding structural wood shear walls) difficult or impossible in most areas.
